# Effective SAFETY Solutions

Company: Alcoa

Location: Primary San Ciprian

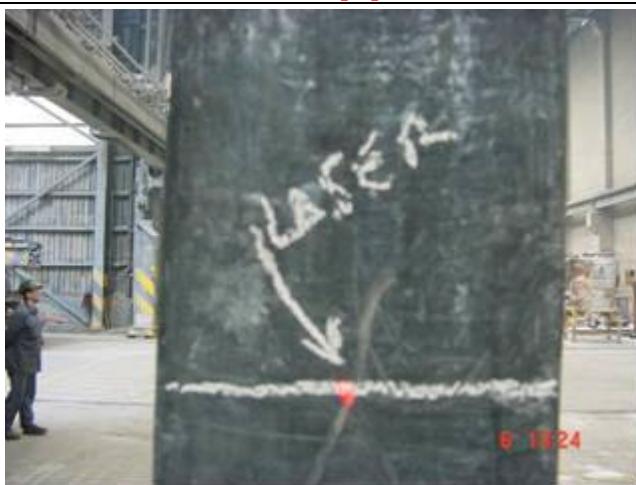
Figure 1.- The implementation of laser reduced frequency

Two different actions were taken to solve this issue. In one side, the number of times needed to enter and exit the crane cab was divided by 2, so exposure to this hazard was also divided. By the other side, pneumatic stair was readapted to improve access and eliminate the hazard of an unexpected movement due to an absence of pressure in the pneumatic circuit.

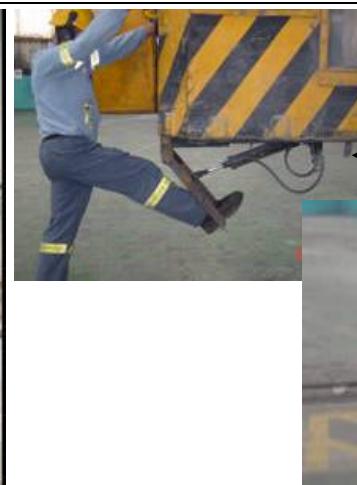
If we review accident history in the potroom department, several accidents in the past were related with people falling while getting into the Pot tender crane cab.

Previous condition and hazard

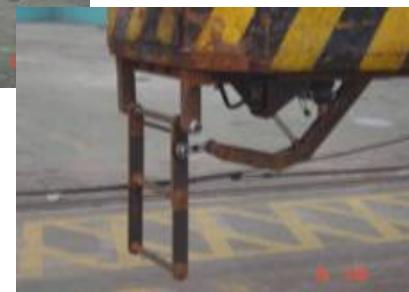
Figure 2 .- This modification keeps stair fixed even without power or air supply fail.
