Effective SAFETY Solutions

Company: Assan Demir ve Saç Sanayi A.S.

Aluminium coils rolled down the pedestrian area

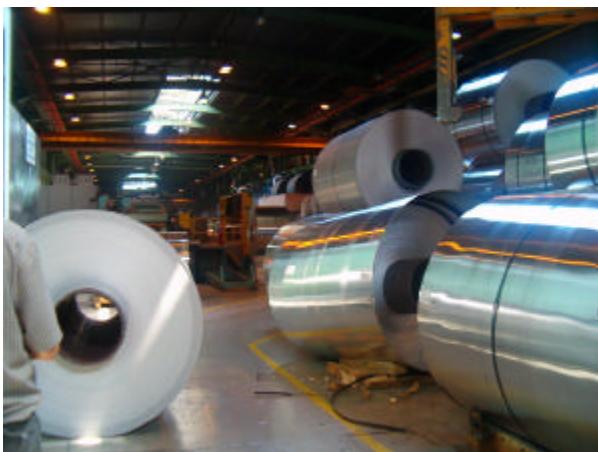
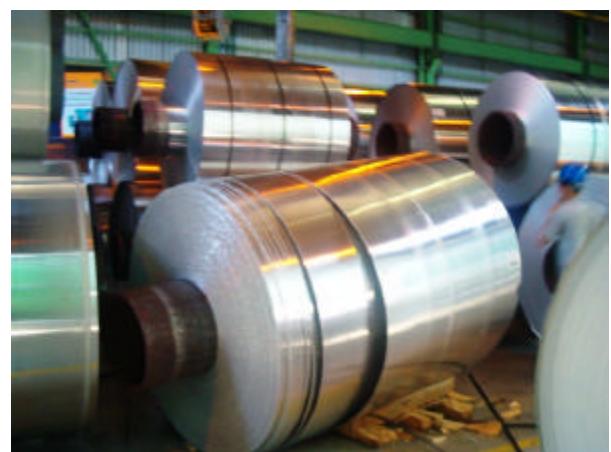
Figure.1 & 2 Stored coils jumped over the palette and fell on the pedestrian area.

To prevent coils rolling down we made the steel shelves to store the coils. Also we put steel bars both end of the coil storage lines

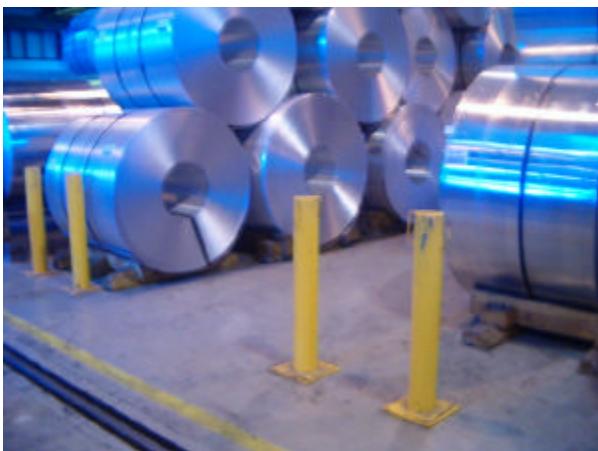
Figure.3 Steel bars were mounted both end of the Storage lines of the coils.

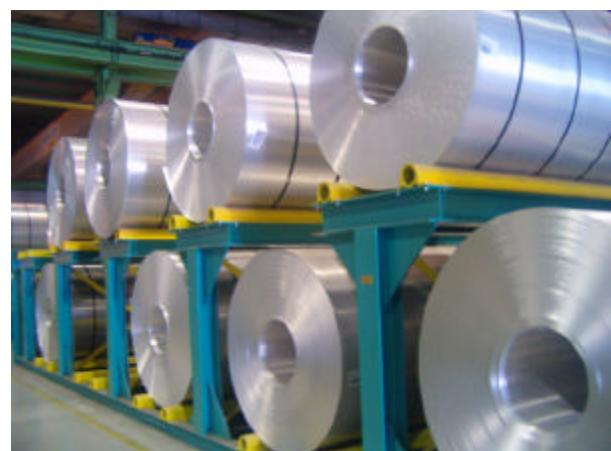
Figure 4. New coil storage shelves were made.
