# Effective SAFETY Solutions

Company: Assan Demir ve Saç Sanayi A.S.

Business: Aluminium sheet and foil products

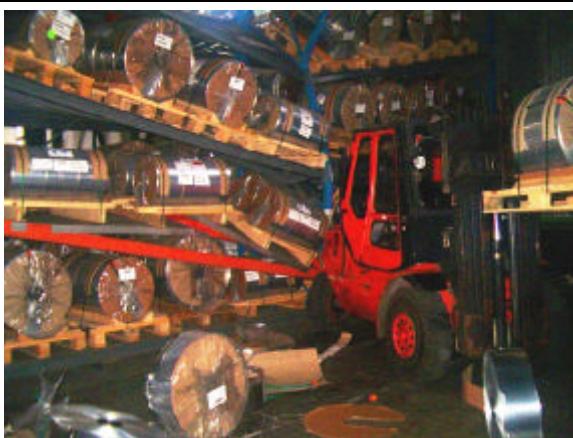
Packaging department forklift crashed to the storage shelves. Shelves collapsed causing without any injury. Package of 6000kg material and exhaust pipe of the forklift were damaged.

Figure 1. Forklift crashed storage shelves.

4 Inches steel bars were mounted in front of the each column of the shelves.

First two layers of the shelves were supported by additional steel profile.

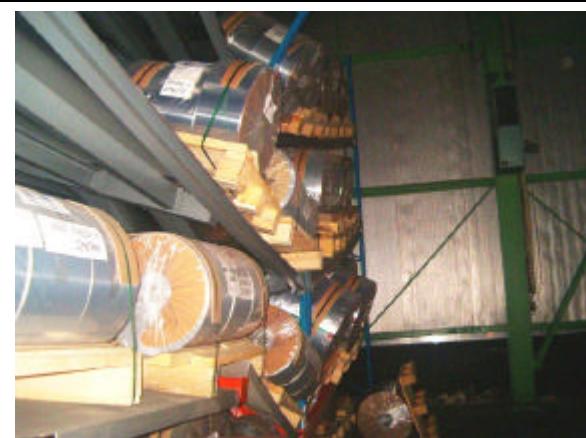
Figure 2. Shelves collapsed, packages fell down

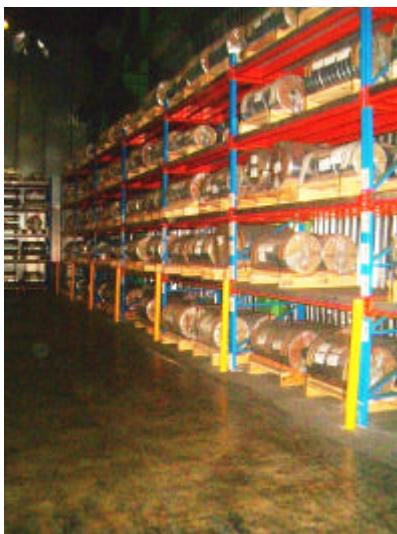
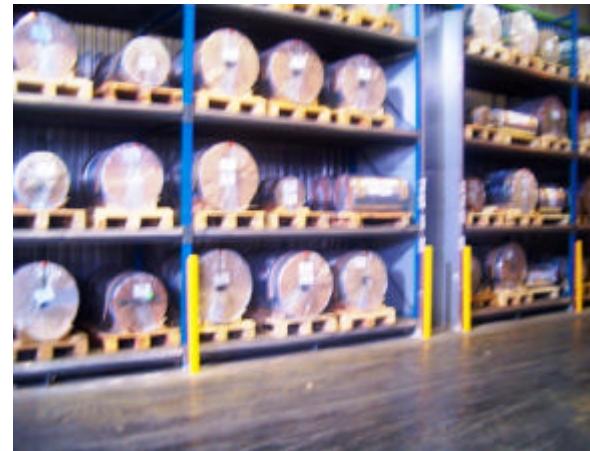
Figure 3. & 4. Steel bars were mounted in front of the column of the shelves
