Effective SAFETY Solutions

Company: ALCOA

Location: PRM SAN CIPRIAN

THE ISSUE

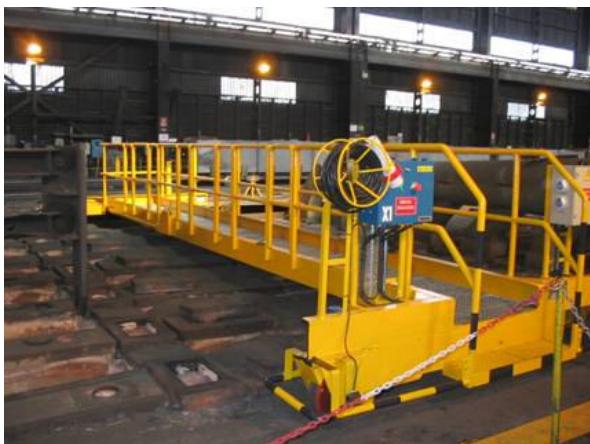
Figure 1. Flue wall inspection machine.

To eliminate unsafe work incentives, a machine (customized mobile equipment) was designed and built to perform this operation. This equipment provides collective protection while performing the task. It also provides power that can be used to connect portable lights or tools and use them to perform inspection tasks, in the past large extension cords were needed.

- Provides collective fall protection for inspecting baking oven pits.
- User friendly and no fall protection PPEs needed.
- Low speed and safety device to prevent pedestrian - mobile equipment interaction hazards.
- Limit extension cords use to provide power.

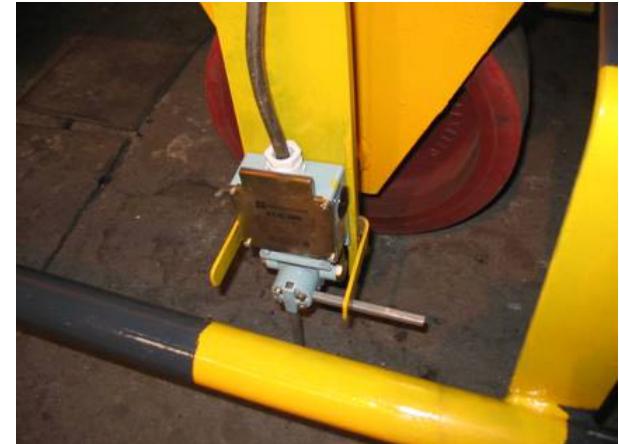
Figure 2. Safety device detail.
