Effective SAFETY Solutions

Company: ALCOA.

Location: PRM SAN CIPRIAN.

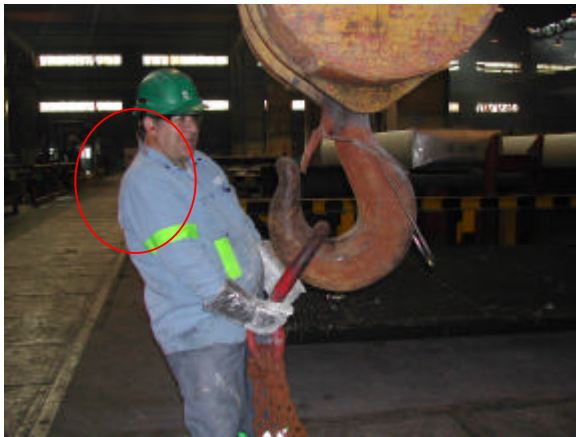
In the past, the chain storage requires operator to handle it in order to hook it with the overhead crane. This creates basically pinching hazards and ergo related hazards. Operators suffered back and hand injuries while performing this task.

Figure 1.- Previous condition, ergo and hand injury hazards.

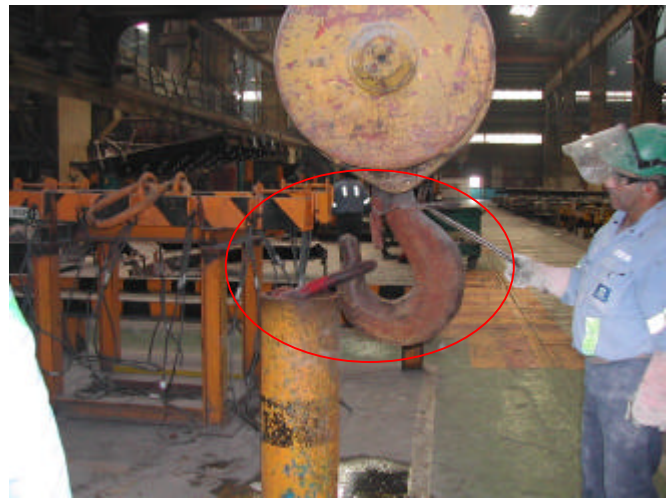
Figure 2.- Current condition.

A simple and easy storing system was designed and implemented. A vertical tube is used to store the chain, but the connection between the chain and the hook of the crane is not able to enter the tube. The operator just need to lead the hook using the handle to connect the chain to the overhead crane.

- Elimination of pinching hazards.
- Elimination reduction of ergo hazards while handling the below the hook lifting device.
